CCMVCD RFQ/P
APPENDIX 1 – UNDERGROUND UTILITIES
BY GPRS

DISCLAIMERS

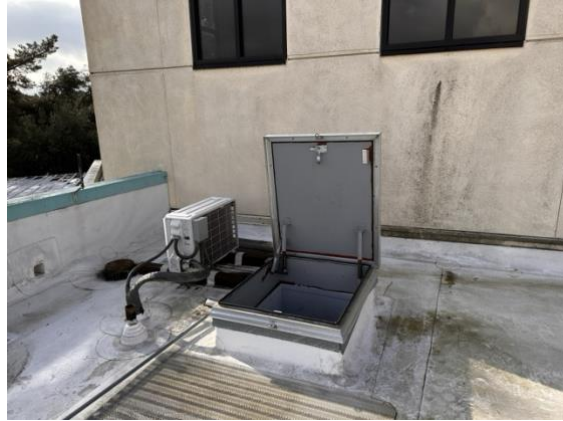
2. Overview photo of the roof. The roof is weathered and at the end of its service life. Ponding has caused the membrane to completely fail and has left the underlying scrim visible in isolated areas. Shrinkage/tenting was also observed.

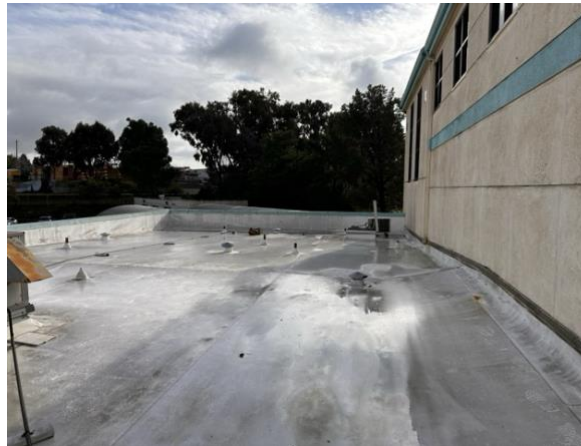
3. A core sample was taken to identify the existing roof construction. An old built-up roof in hot asphalt was discovered underneath the existing TPO membrane. There was no coverboard separating the 2 roofing systems, a poor roofing practice.

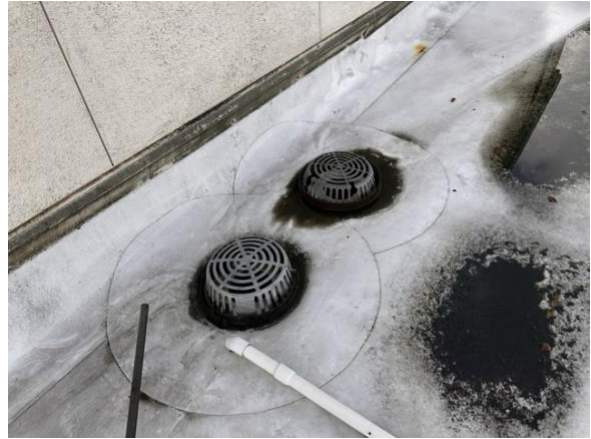
5. Close-up photo of rusting gutters and gutter joints. The gutters actively leaking due to rust.

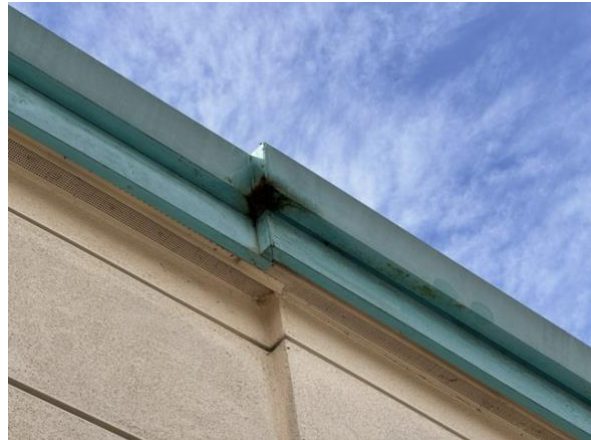
6. Rust is present on the membrane due to leaking gutters. This was observed in multiple areas.

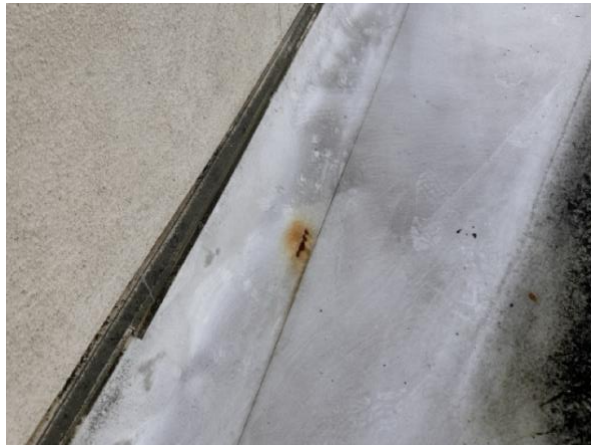
7. Close-up photo of rusting downspout. The gutters, downspouts, and any fascia board that are damaged should also be addressed concurrently with any roofing project.

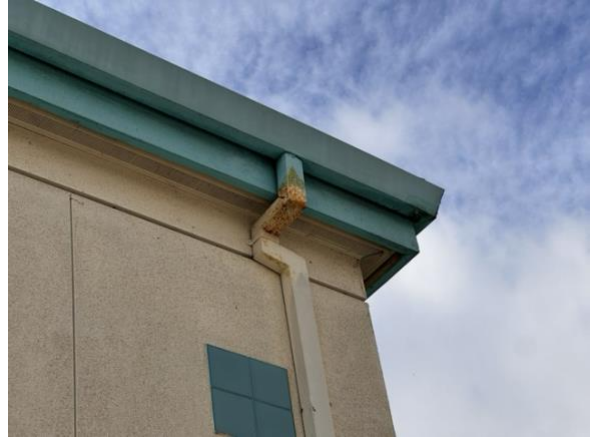
8. An overview photo of fiberglass skylights. On average, the lifespan of fiberglass skylight is 20-40 years depending on quality of the product, maintenance, and other environmental factors.

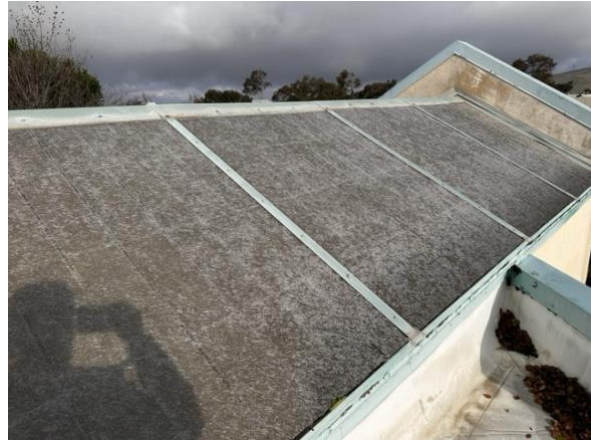
9. Close-up photo of outstanding roof maintenance needs. These areas will retain moisture causing deterioration of the membrane.

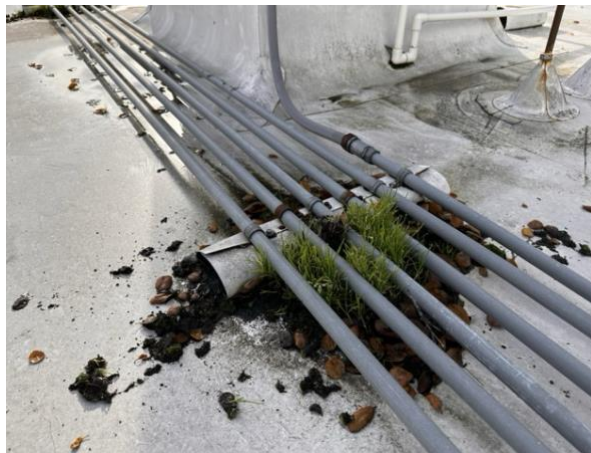
10. Close-up photo of heavy weathering to the membrane exemplified by ponding. The underlying reinforcing fibers have been exposed as the top layer of the membrane have completely worn away.

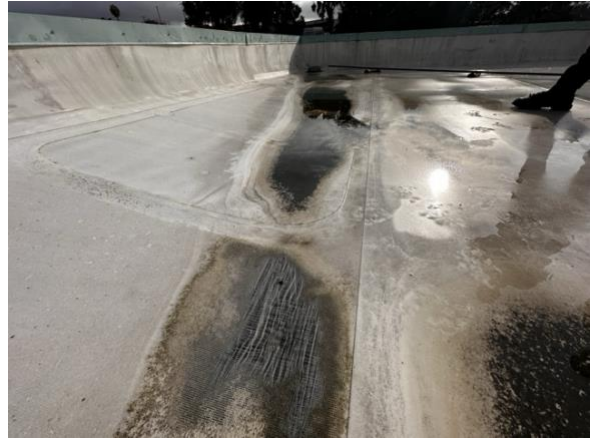
11. Close-up photo of further TPO membrane failure due to ponding.

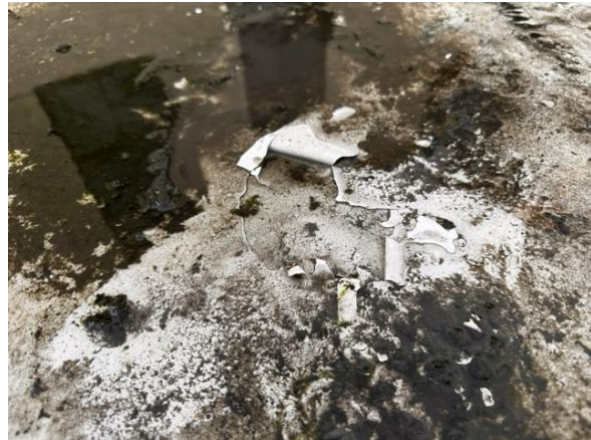
12. The façade has cracks and should be addressed given the age of the building. Tremco's façade division have inspected and made a recommendation on how to best resolve this issue.

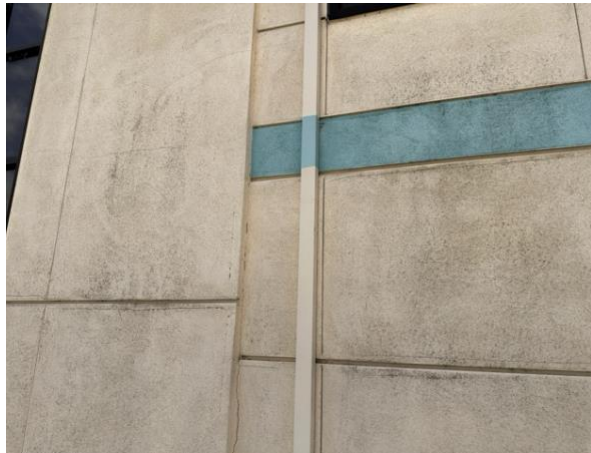
13. 2. §3212. Floor Openings, Floor Holes, Skylights and Roofs.

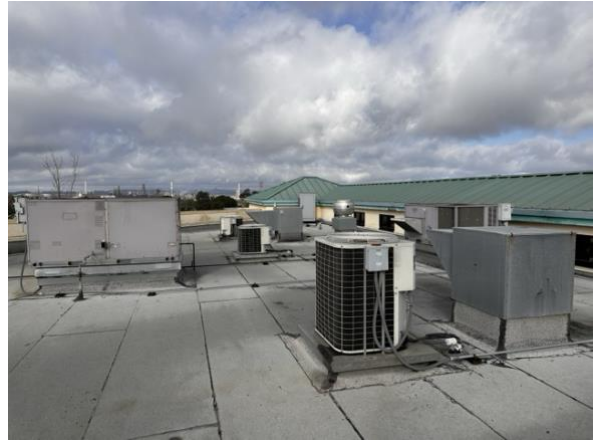
15. A core sample was taken to identify construction of the roof. The original roof was installed directly to the deck. Although delaminating, this installation method has caused the roof to survive longer than its typical life cycle expectancy.

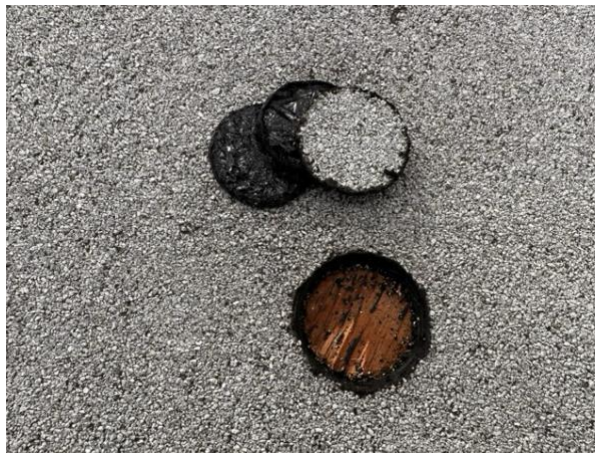
16. Close-up photo of previous repairs.

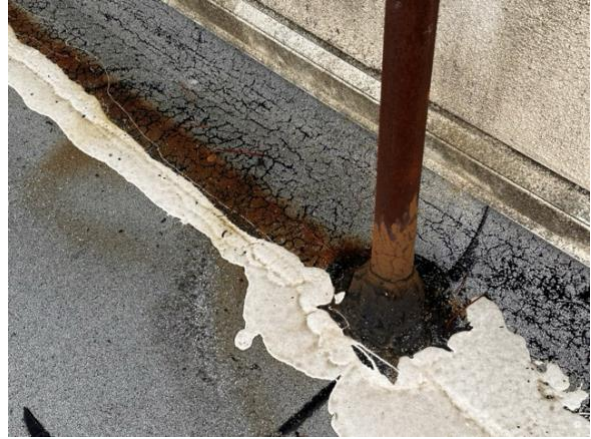
17. Close-up photo of the base flashings. The flashings are suffering from alligatoring, a sign that the membrane is dried out.

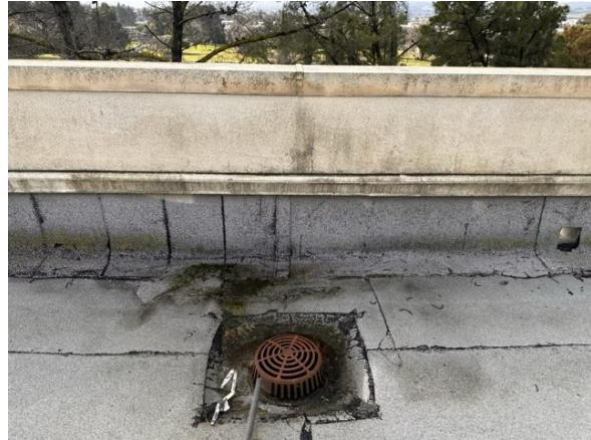
18. Close-up photo of previous repairs made to the scupper.

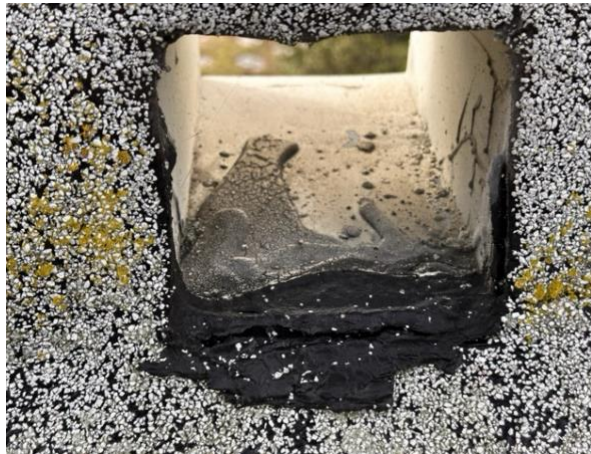
19. Heavy granule loss was observed. Granules protect the membrane from UV exposure. As the granules come free from the roofing plies, they are more susceptible to UV damage which will age the roofing plies more quickly.

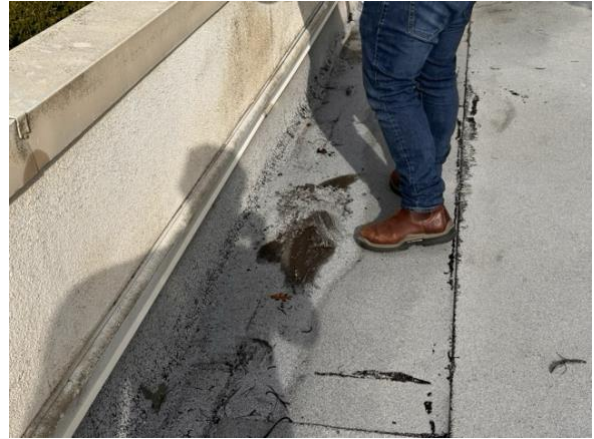
20. Extreme granule loss is present on the base flashings.

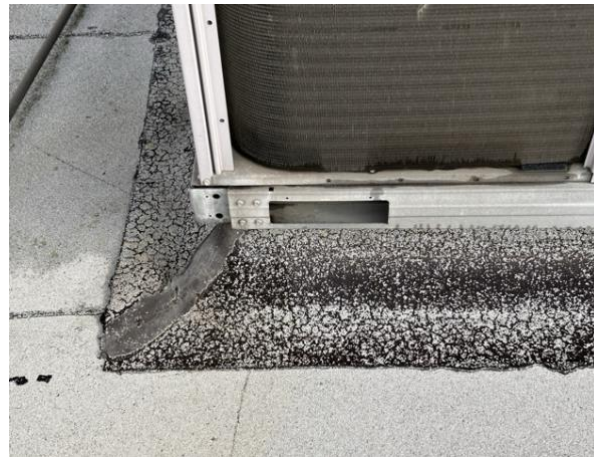
21. Close-up photo of an improperly flashed penetration.

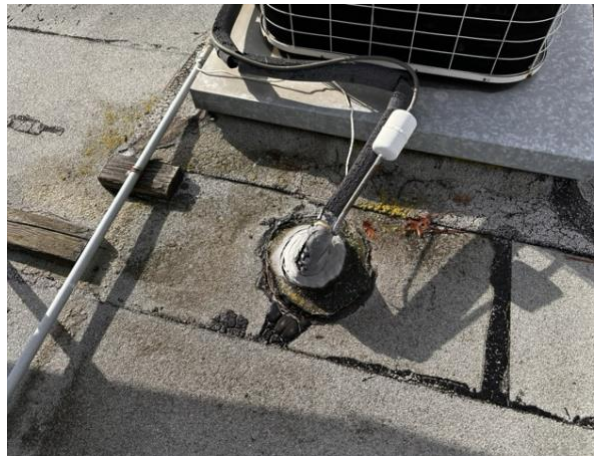
22. The edge metal is beginning to rust due to water intrusion through the rivet heads.

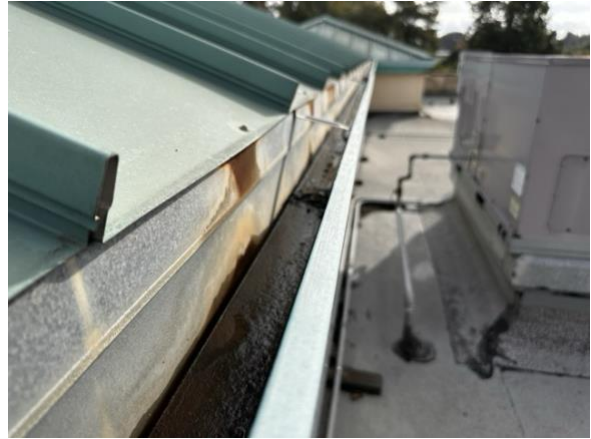
23. The fascia board is currently rotting in some areas, and needs to be painted in other areas.

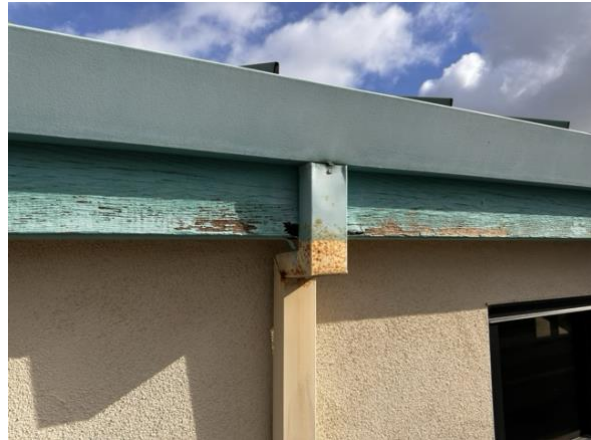
24. The downspout has rusted through.

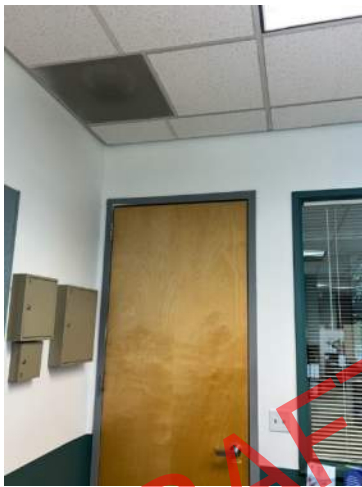
Door to HR Admin Office – door not aligned with jamb.
4102_GEP01_151

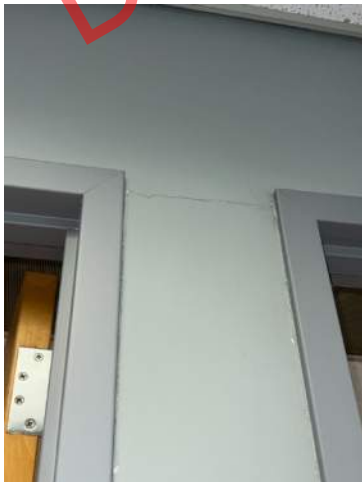
Crack in drywall adjacent to HR admin office door.
4102_GEP01_162

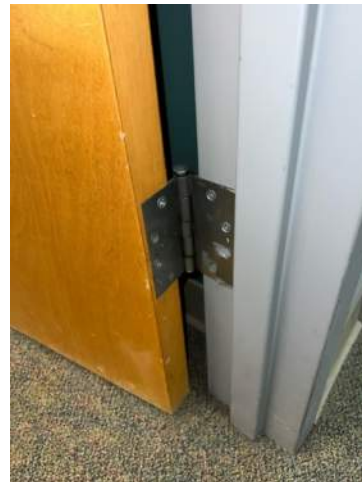
Bottom door hinge seated properly.
4102_GEP01_165

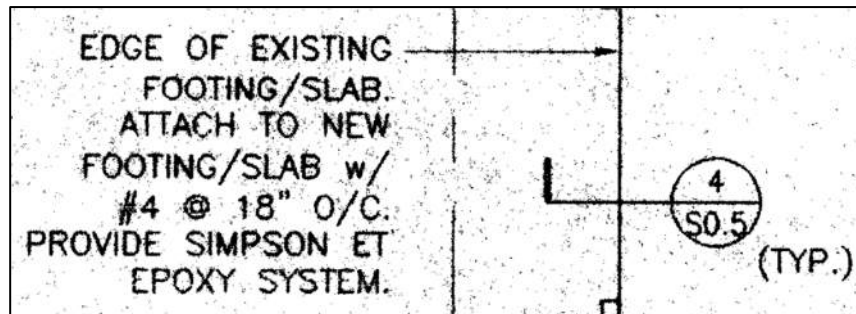
Excerpt from Sheet S1.1

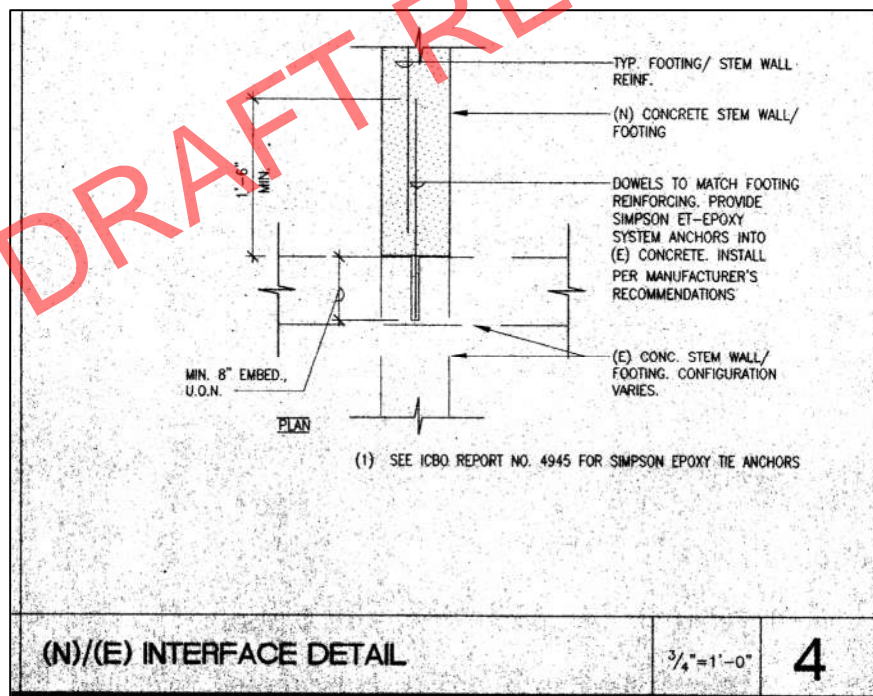
Detail 4/S0.5 – Transition between new/existing stem walls.

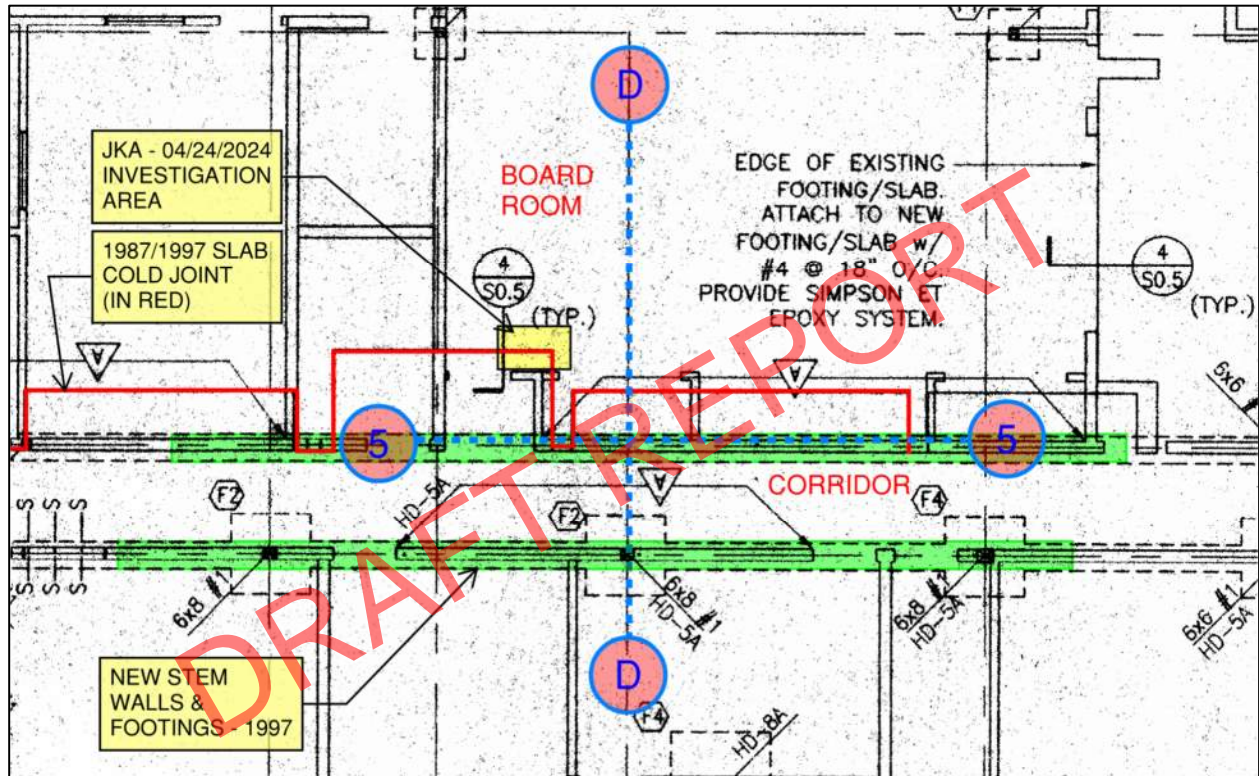
Excerpt from Sheet S1.1 – JKA markups in color

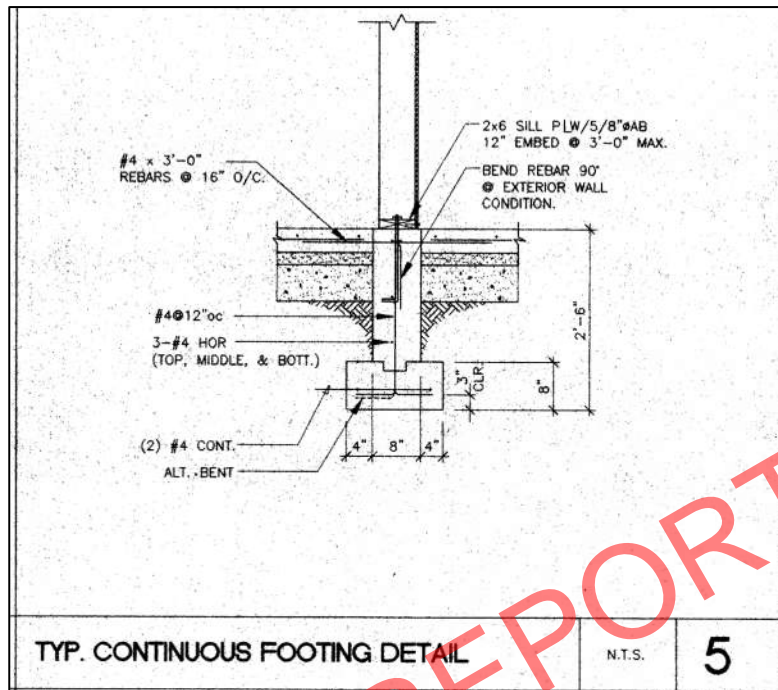
Detail 5/S0.3 from 1997 Addition

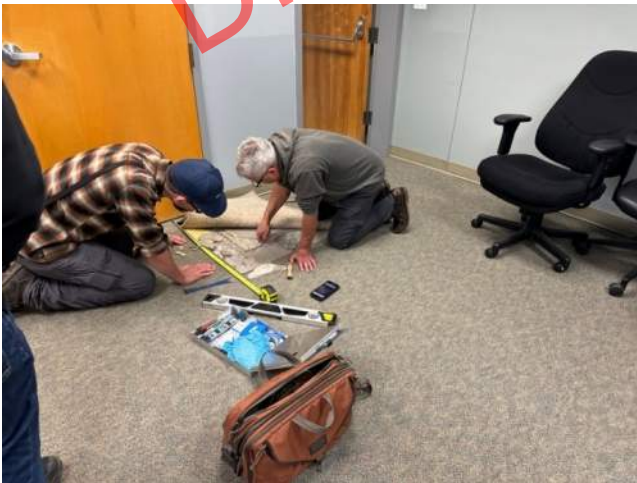
Location of slab investigation in Boardroom
4102_NBL01_374

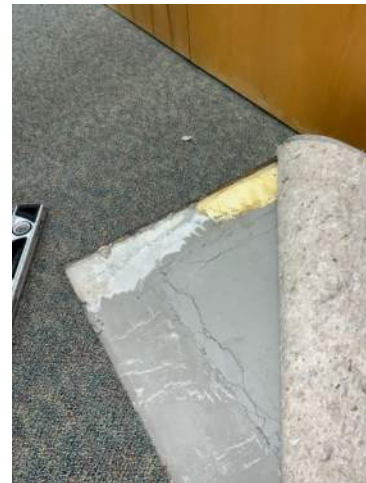
In-situ condition under carpet. 1997 addition side (to the right) appears to be higher.
4102_GEP01_173

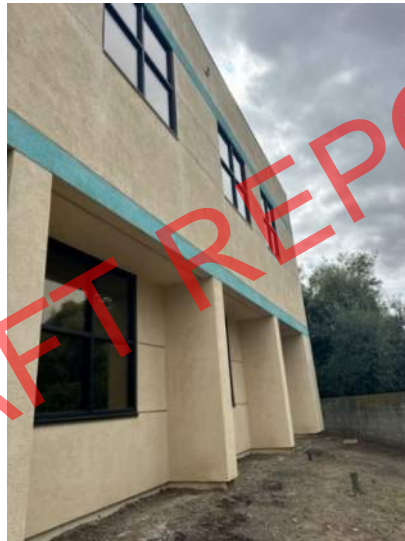
2nd floor windows flush with façade with 1st floor windows recessed back under soffit.

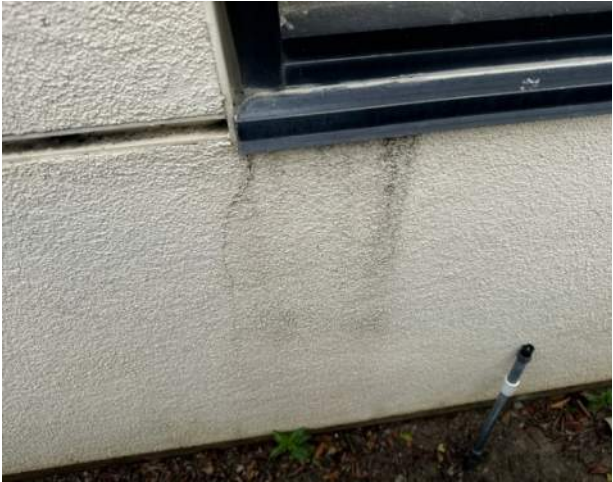
Stucco staining from water discharge under window sill at Window 1.19 – an original window from 1987.

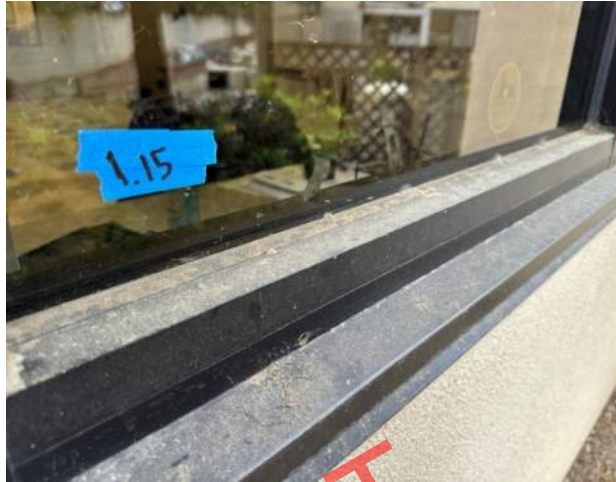
Window 1.15 with weep holes at the sill.

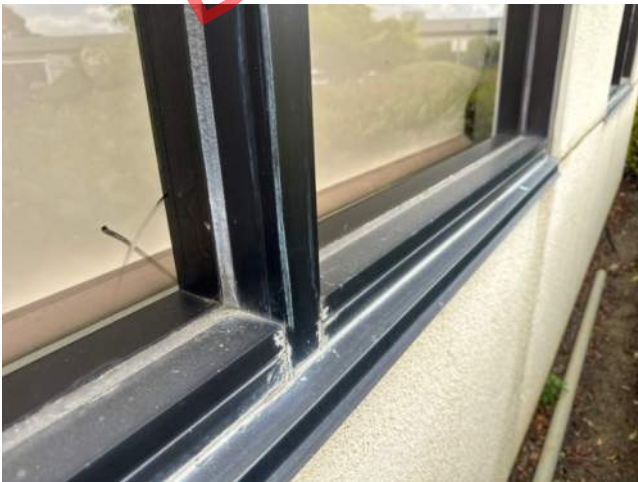
Window 1.19 – reported as active leak. Various joints in window sill have been sealed (white caulking).

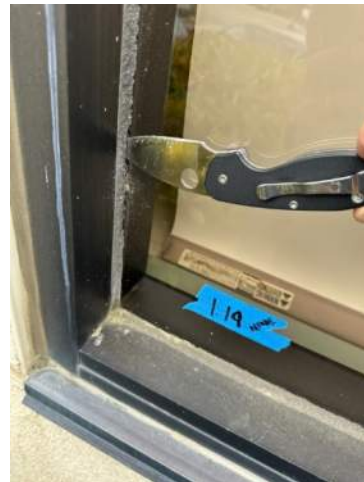
Window 1.19 – failure of wet-set sealant at glazing. Knife blade penetrates approx. 5/8" at gap in sealant.

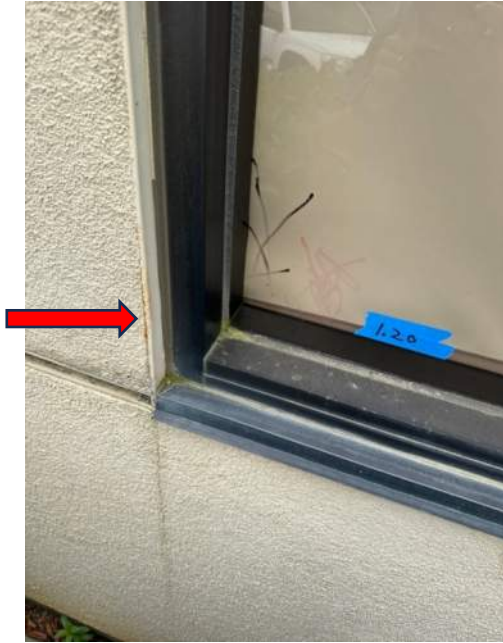
Window 1.20– reported as active leak. Various joints in window sill have been sealed (white caulking). Note rust/corrosion at vertical casing bead.

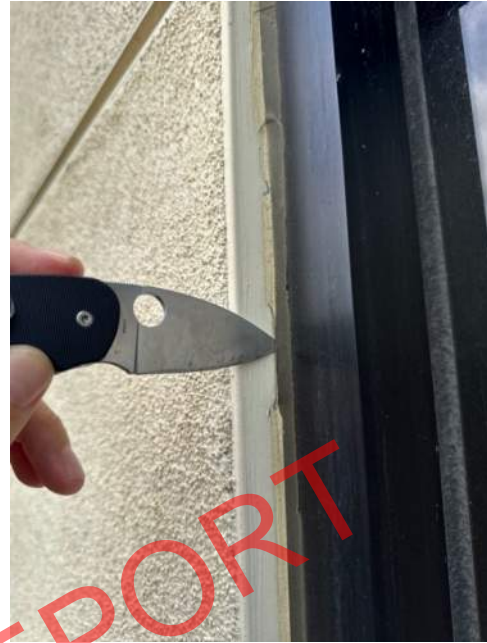
Window 1.20 – sealant failure between window jamb and casing bead.

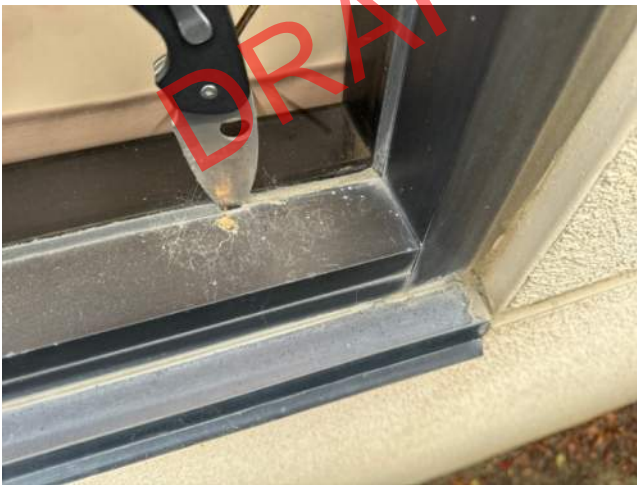
Window 1.20 – Failure of wet-set sealant at glazing.

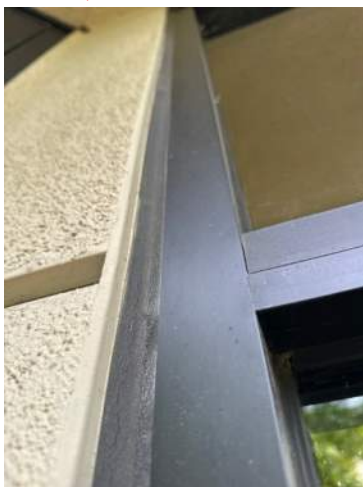
Window 1.09 – Cracked sealant at joint.
4102_NBL01_088

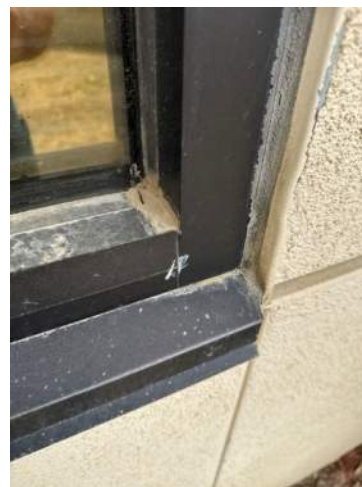
Window 1.11 – Cracked sealant at joint.
4102_NBL01_104

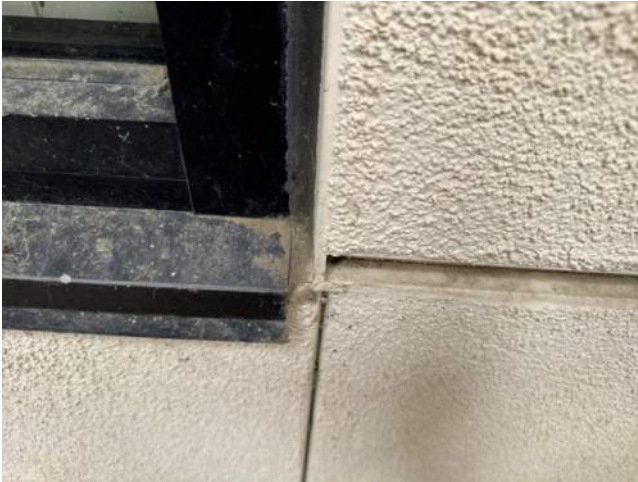
Window 1.16 – Cracked sealant at joint.
4102_NBL01_151

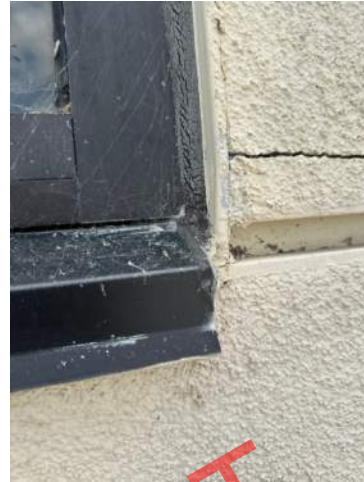
Window 2.15 – Cracked sealant at joint.
4102_NBL01_230

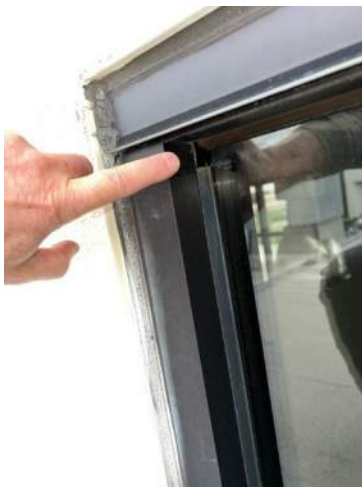
Shrinking at glazing sealant.
4102_GEP01_055

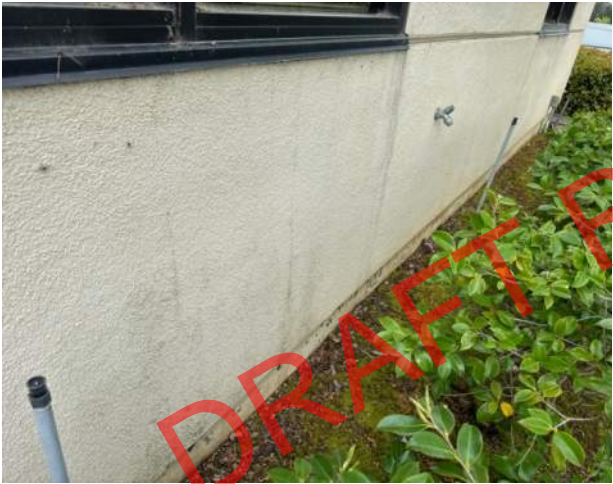
Irrigation Sprinklers adjacent to structure at
Windows 1.04 & 1.05
4102_NBL01_058

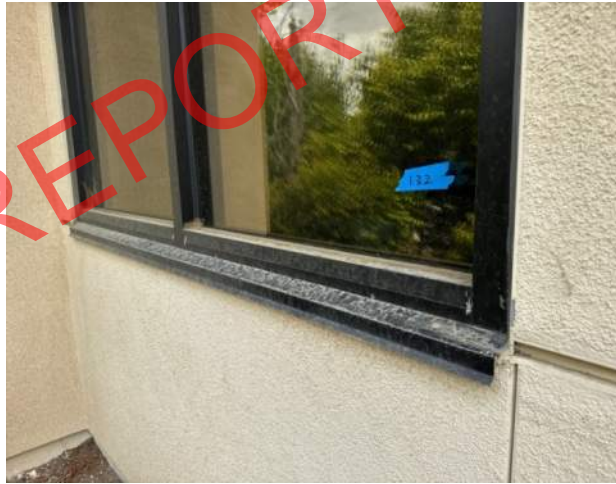
Window 1.32 – Water stippling at base of window.
4102_NBL01_109

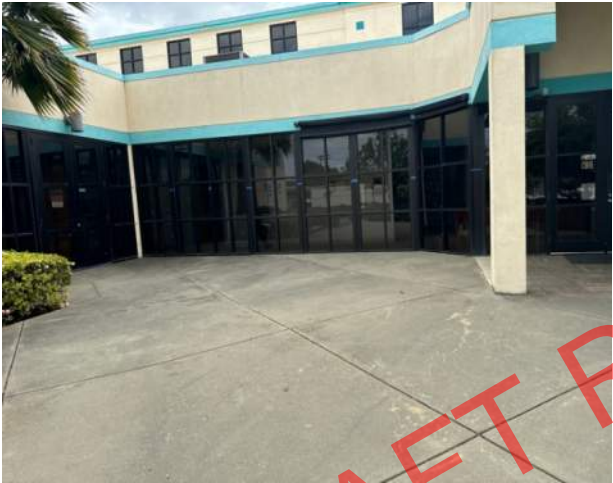
Storefront system at building entry.
4102_NBL01_404

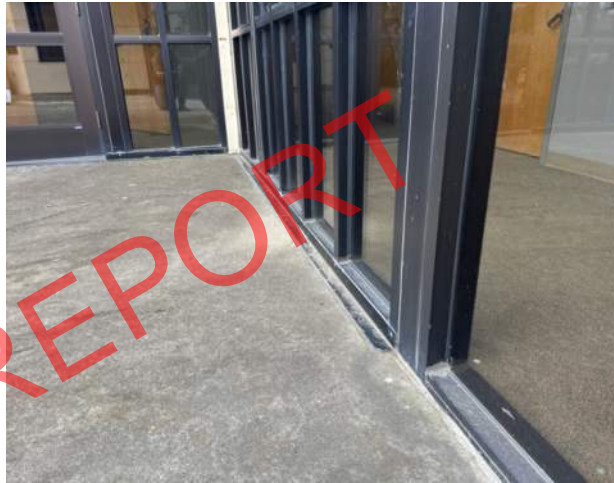
Sealant and L-metal repairs at storefront sill.
4102_NBL01_020

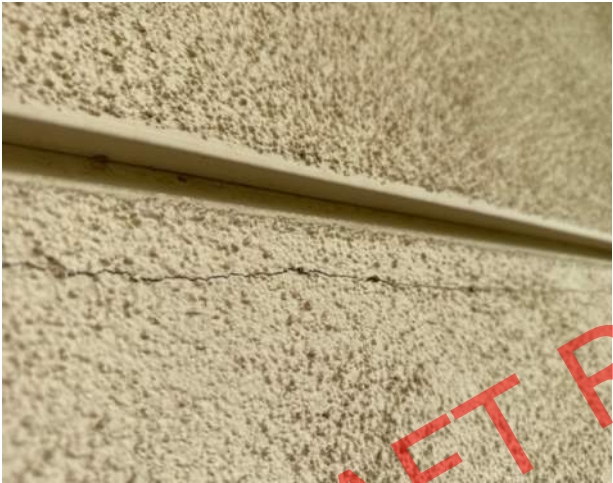
Crack under stucco reveal.
4102_NBL01_093

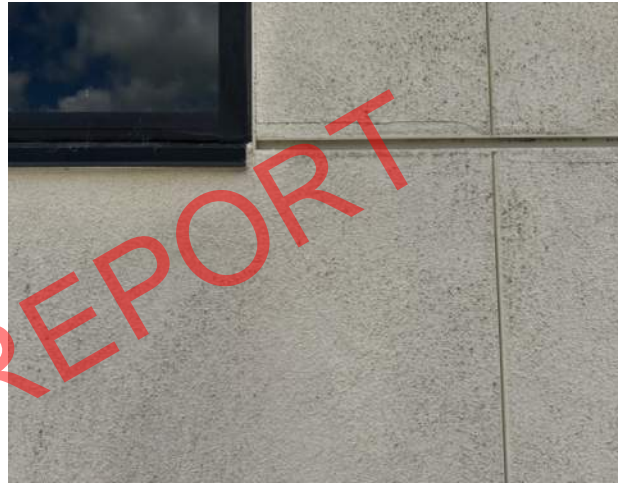
Cracks above and below stucco reveal near
Window 2.16.
4102_NBL01_239

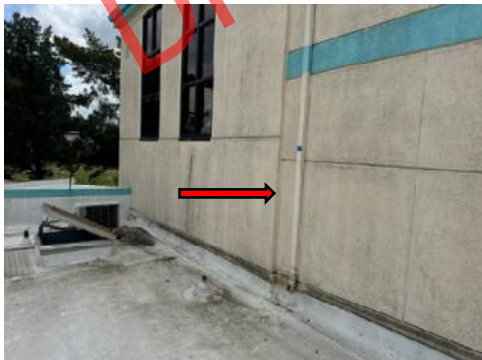
Cracks at small returns in wall at northside of lightwell wall.
4102_NBL01_344

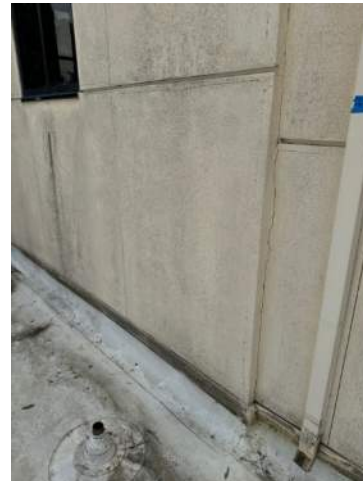
Cracking is stucco at return near Window 2.15
4102_NBL01_245

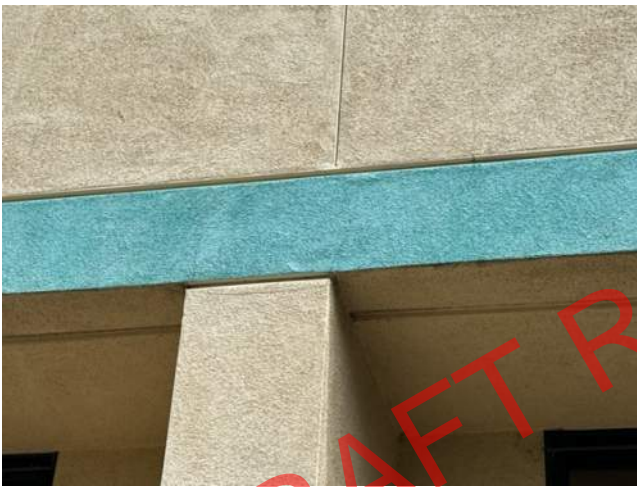
Cracks at wing wall between Windows 2.08 & 2.09.
4102_NBL01_131

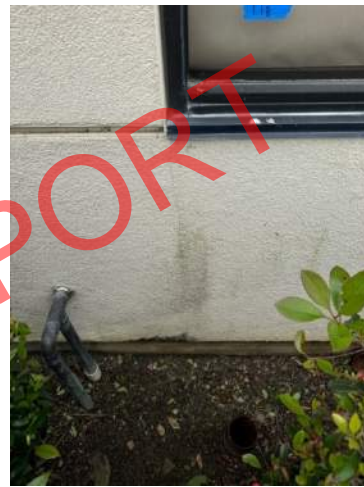
Stucco crack at corner of Window 1.18
4102_NBL01_173

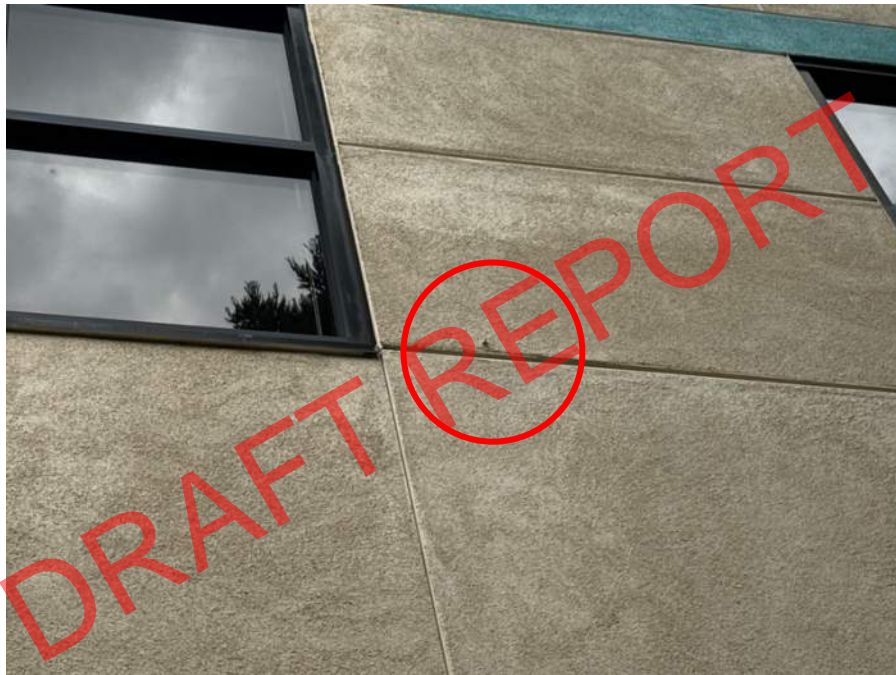
Exposed scaffold tie wire from construction.
4102_NBL01_154

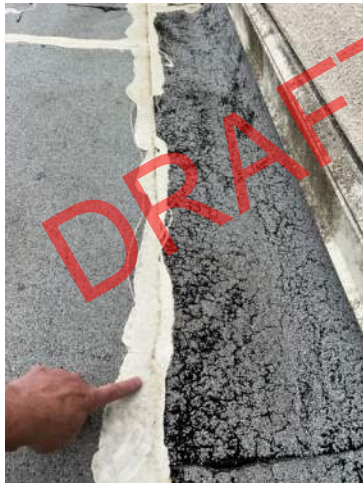
Missing granules at parapet transition. Improper edge sealing.
4102_GEP01_050

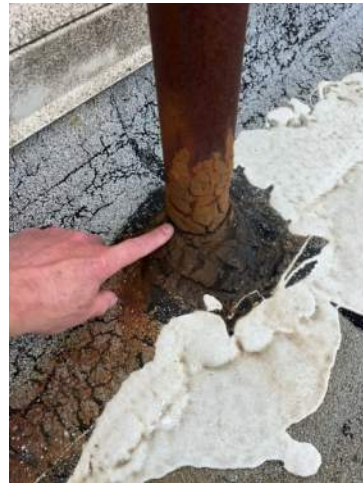
Gaps at sealed roof penetrations.
4102_GEP01_052

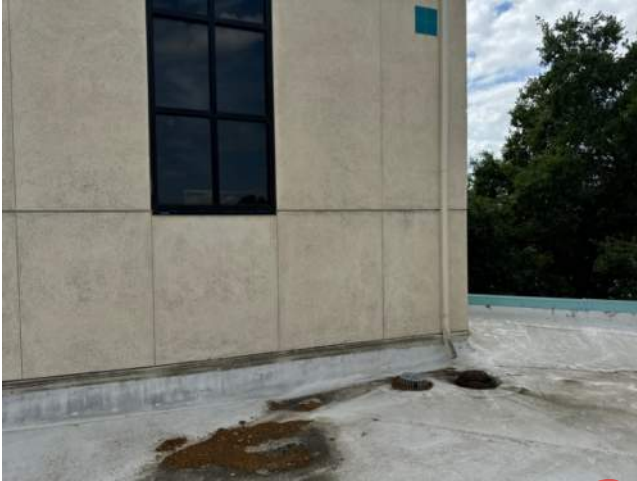
Low Roof - Insufficient sloping and drains at high point – near Window 2.25.
4102_NBL01_335

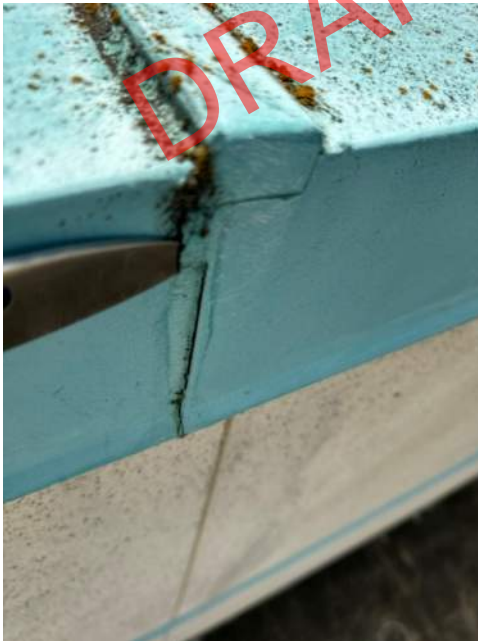
Failed sealant at parapet cap couplers.
4102_NBL01_356

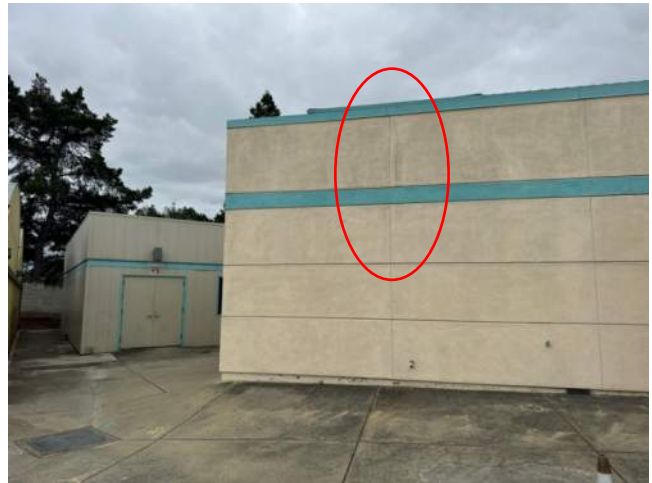
Staining at exterior walls under parapet cap coupling brackets.
4102_NBL01_014

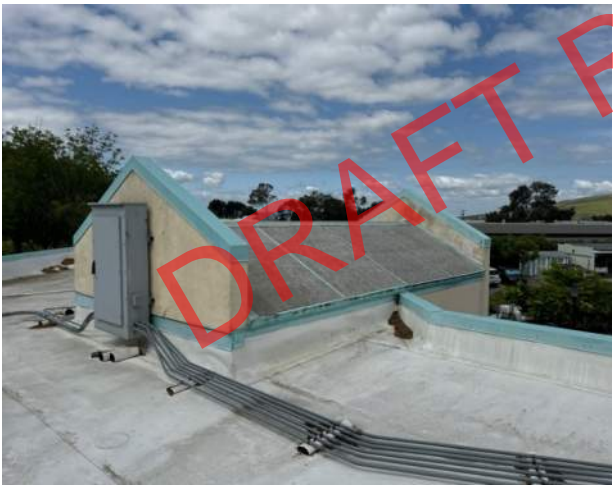
Skylight at Building Entry Roof
4102_NBL01_311

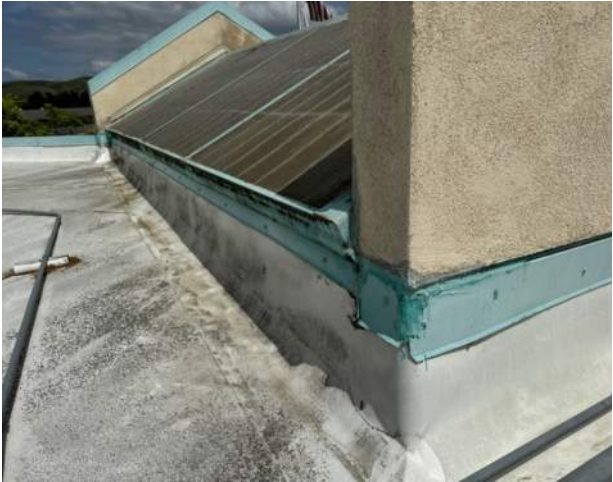
Remedial sealant repair attempts at skylight perimeter.

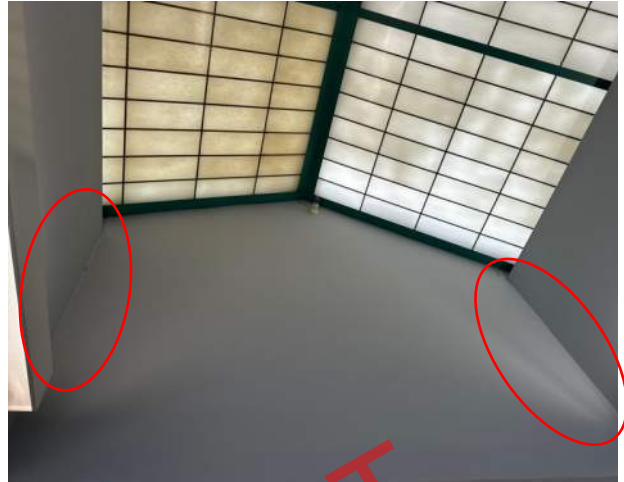
Staining at interior atrium at skylight corners.

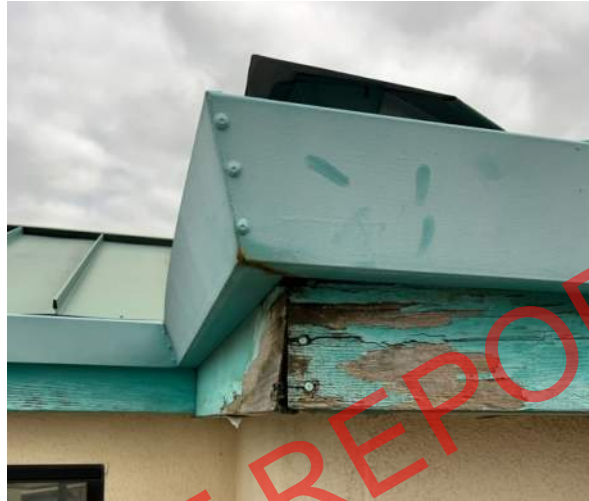
Rotted Wood Fascia.
4102_GEP01_054

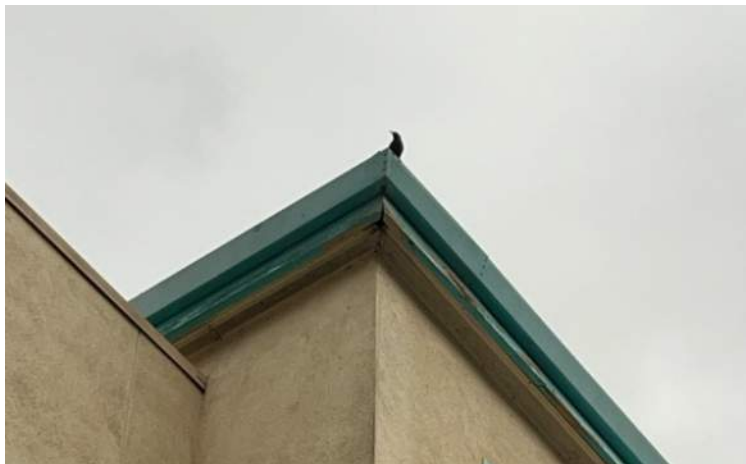
Nesting birds at damaged tower soffits.
4102_GEP01_026

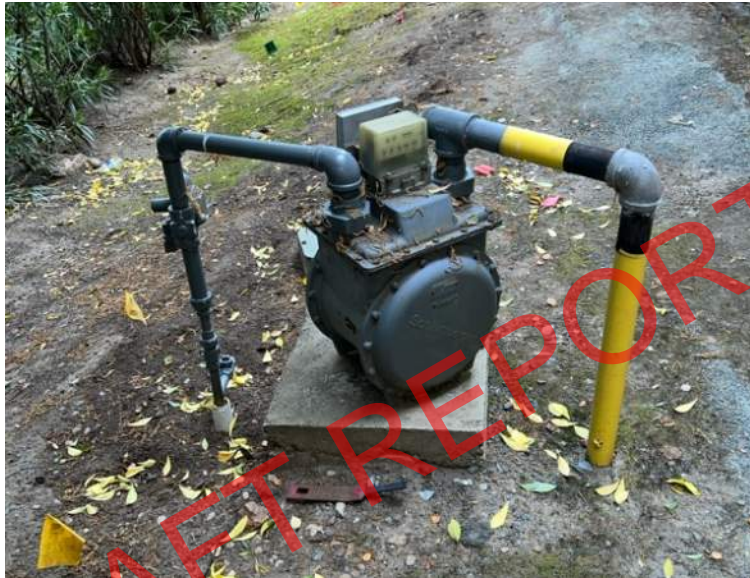
No seismic safety valve at gas meter.
